ROOF REPLACEMENT PROJECT
 883 MAIN STREET
 TORRINGTON, CT
 FOR
 McCall Foundation Inc.

Drawing Title:
 Roof Plan
 Roof Details
 Date 12/04/2024
 Scale 1/4"=1'-0"
 Job No.
 CDN.
 Drawing No.
A1

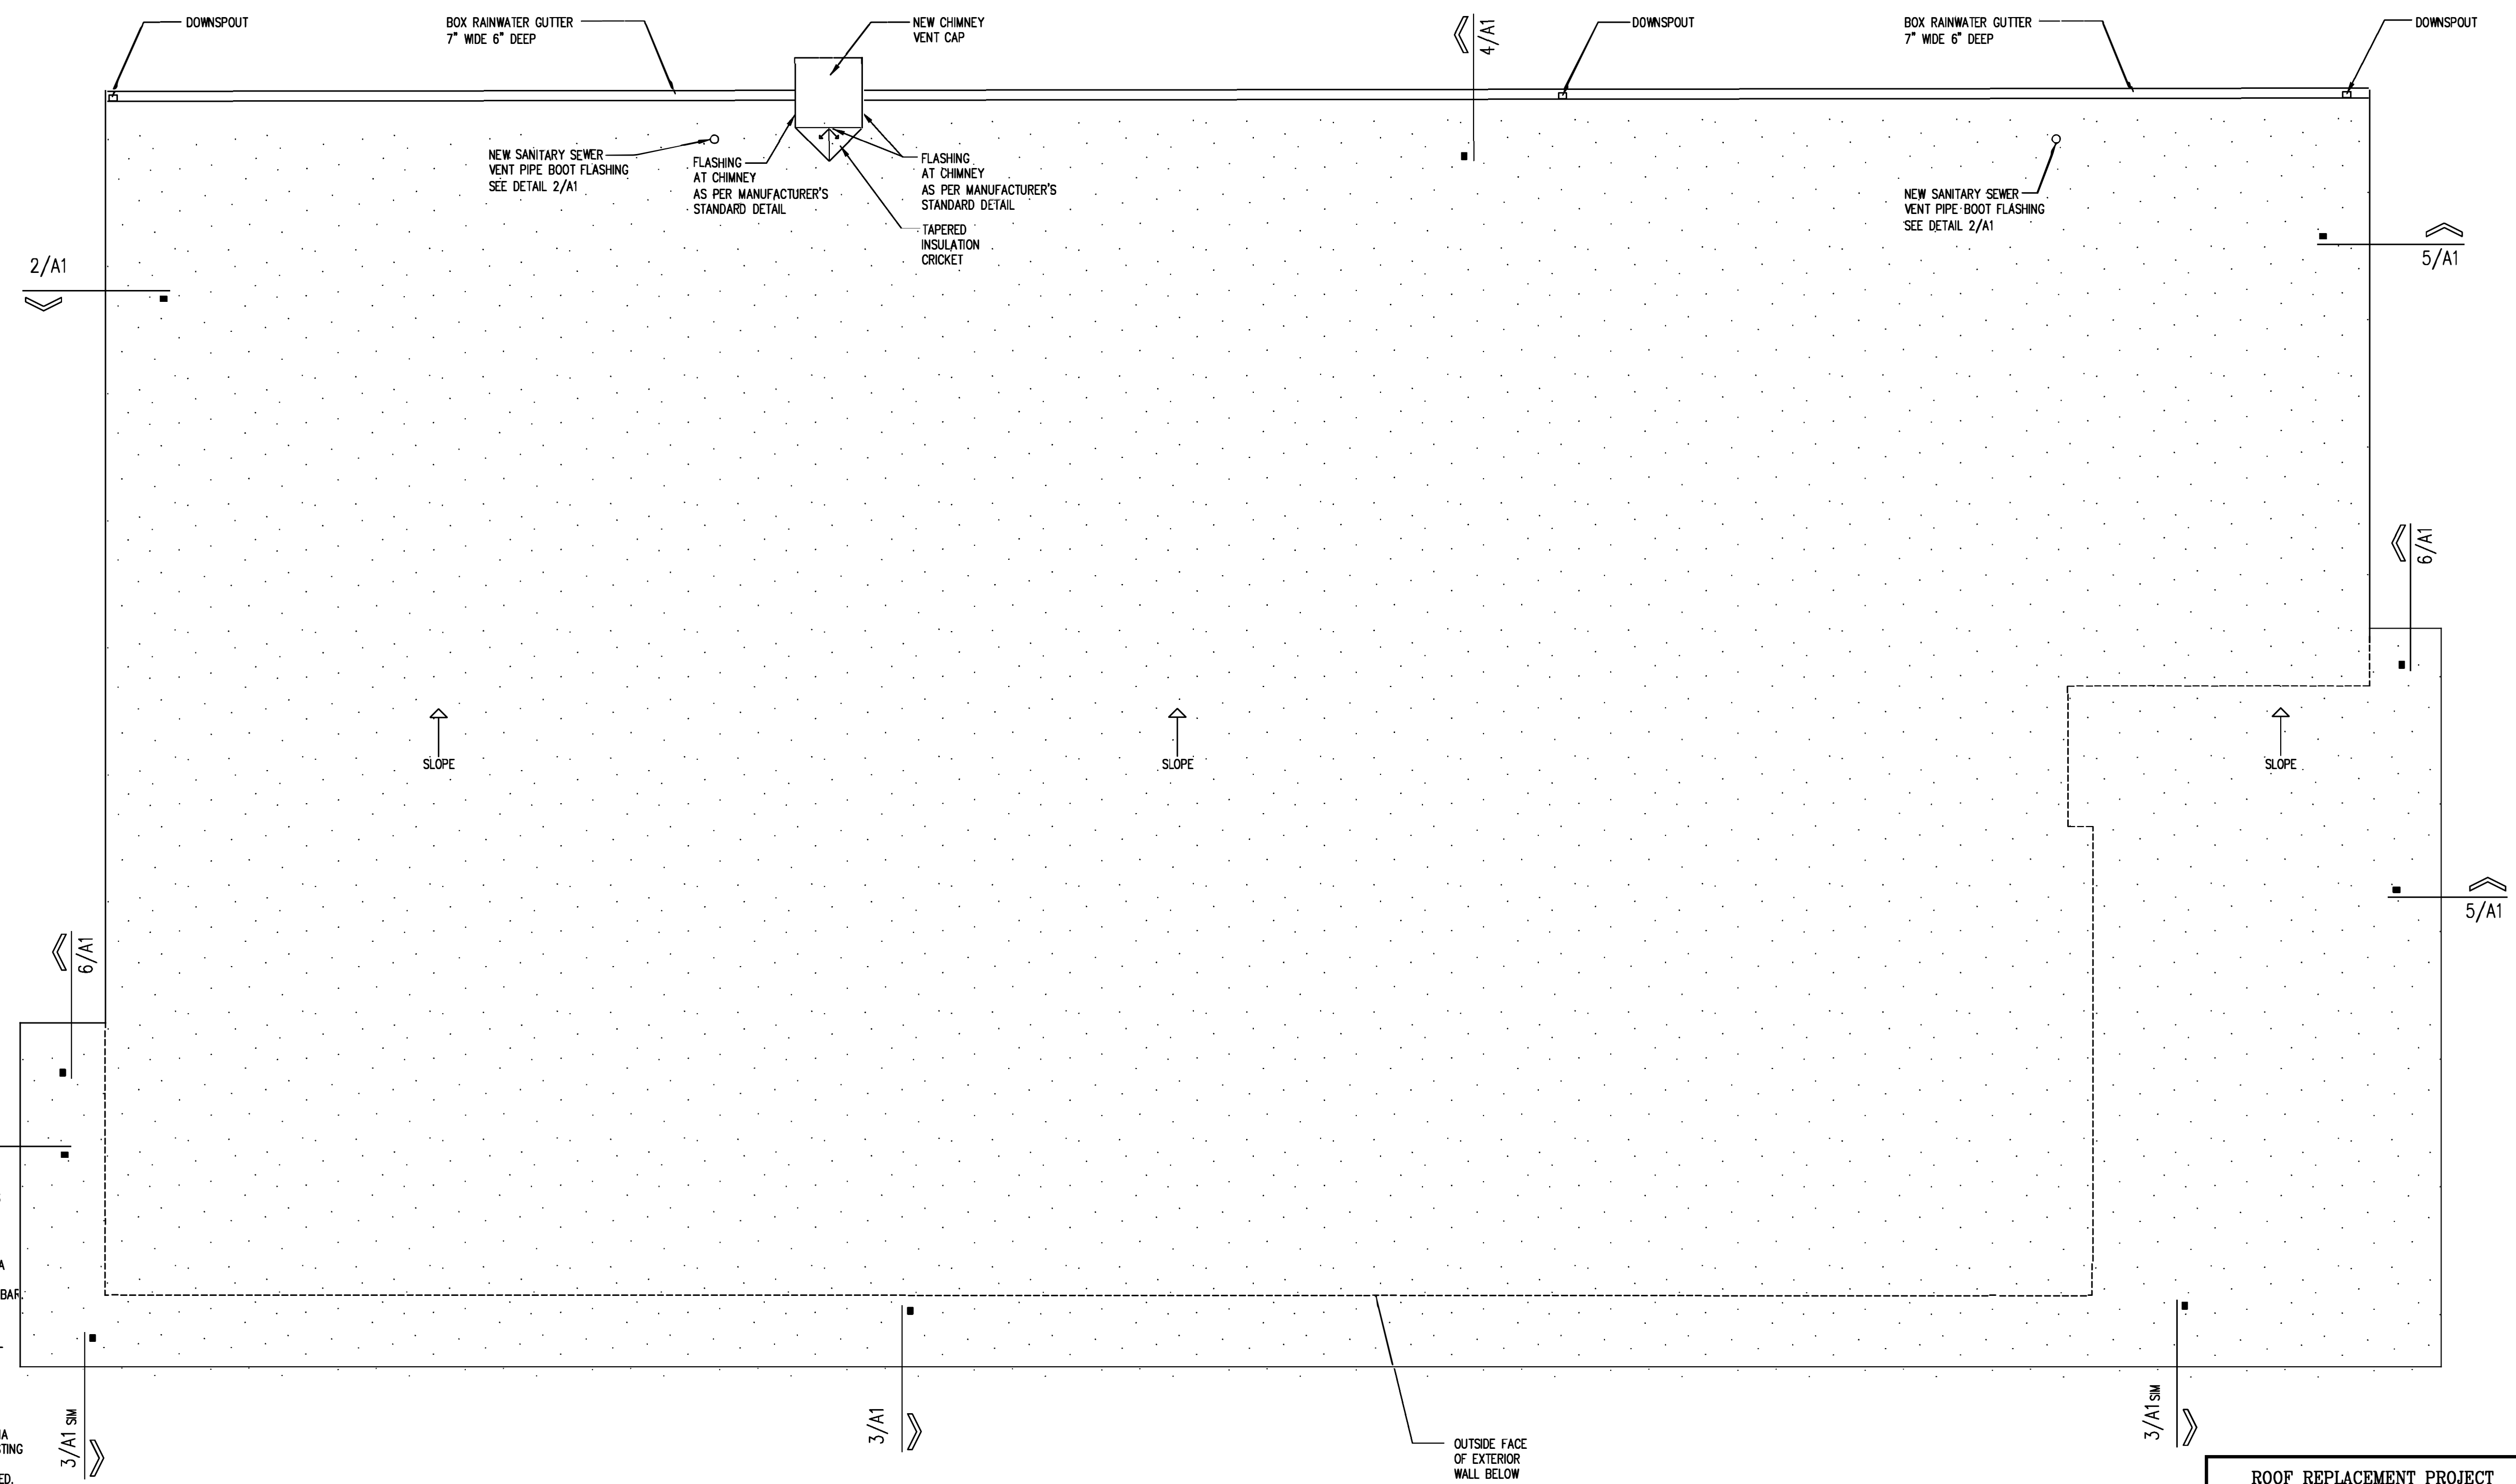
1 ROOF PLAN
 A1 1/4"=1'-0"

ROOF DEMOLITION NOTES: REMOVE EXISTING EDPM ROOF AND UNDERLAYMENT BACK TO ROOF DECK, REMOVE EXISTING RAINWATER GUTTERS AND DOWNSPOUTS, REMOVE ROOF CAP FLASHING.

PROTECT ALL OPEN AREAS OF ROOF AS REQUIRED TO PREVENT WATER INFILTRATION INTO BUILDING. DO NOT REMOVE ANYMORE EXISTING ROOFING THAN CAN BE MADE WEATHER TIGHT AT THE END OF THE DAY.
